MEMORANDUM

DATE: November 19, 2018

RE: Hinsdale School Culvert and Flooding
Winsted, CT

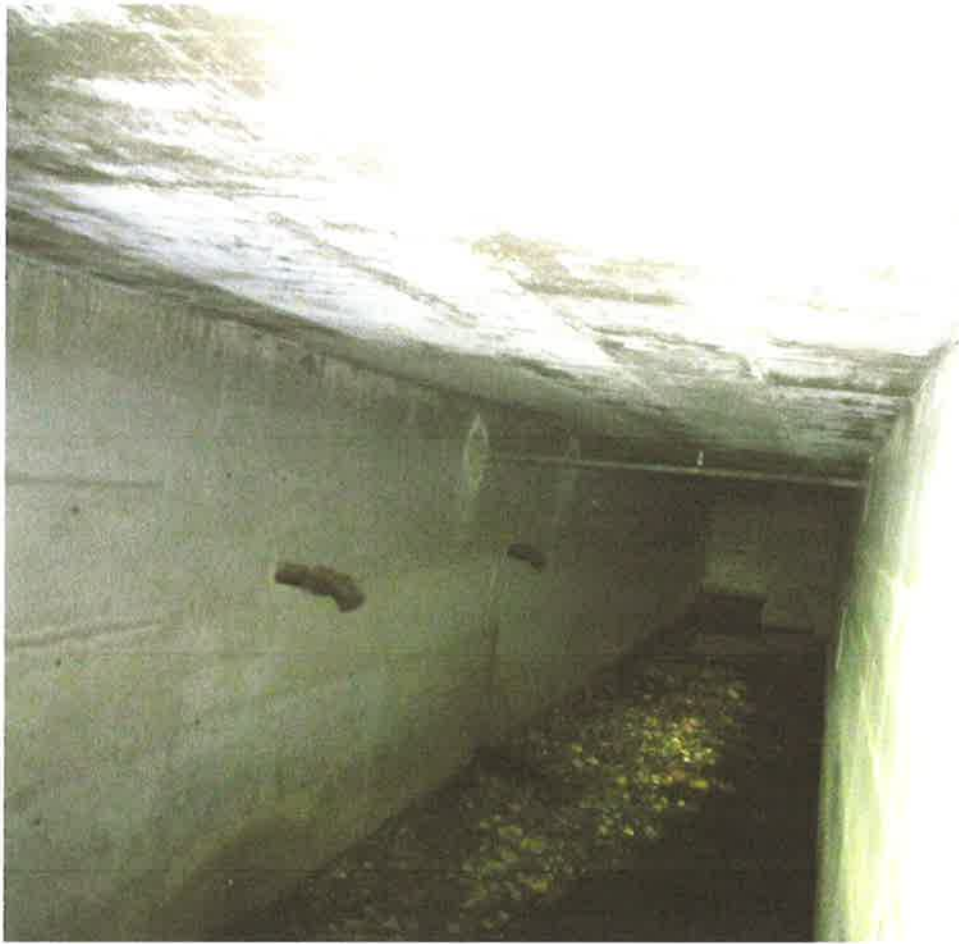
Culvert looking upstream

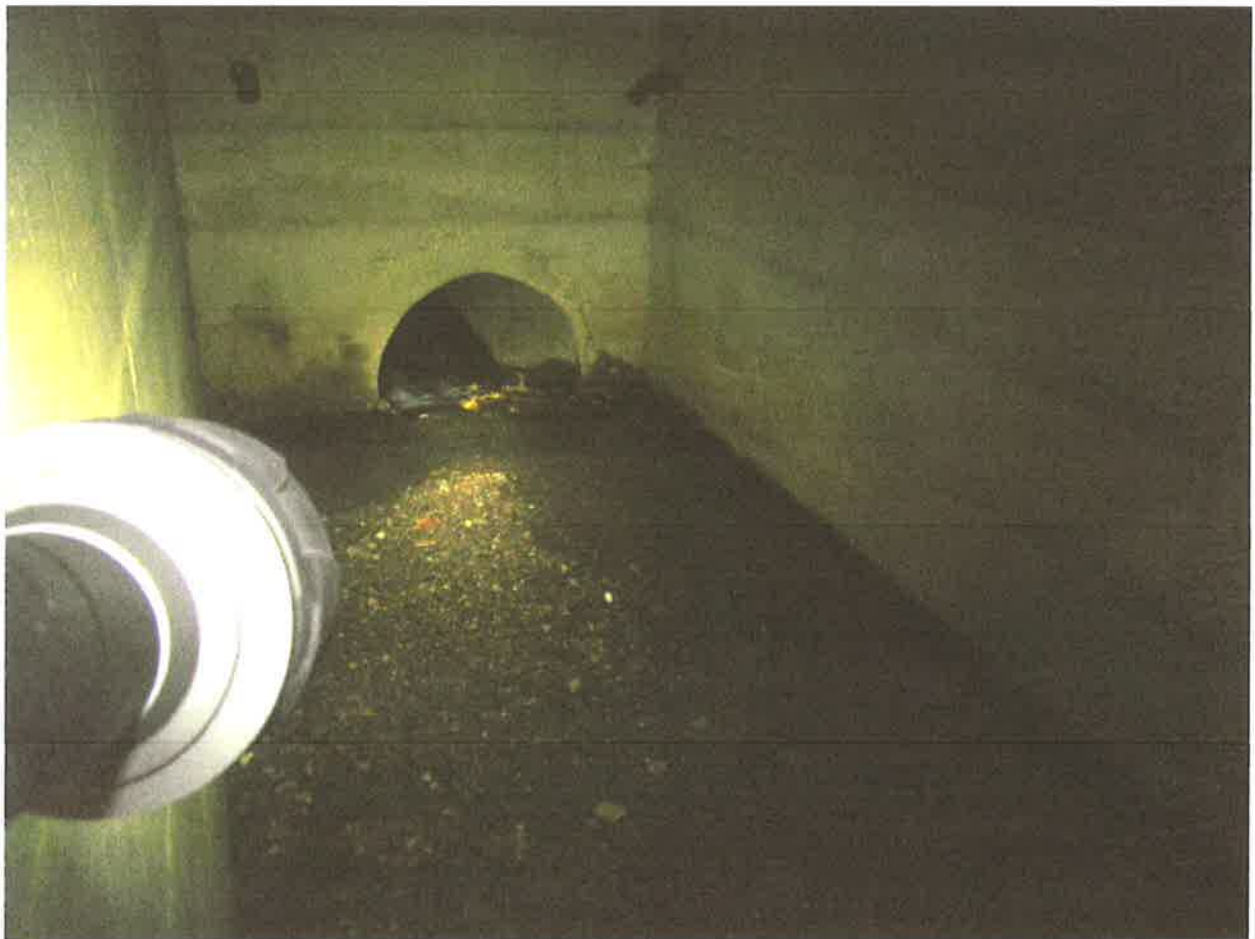
Culvert looking downstream

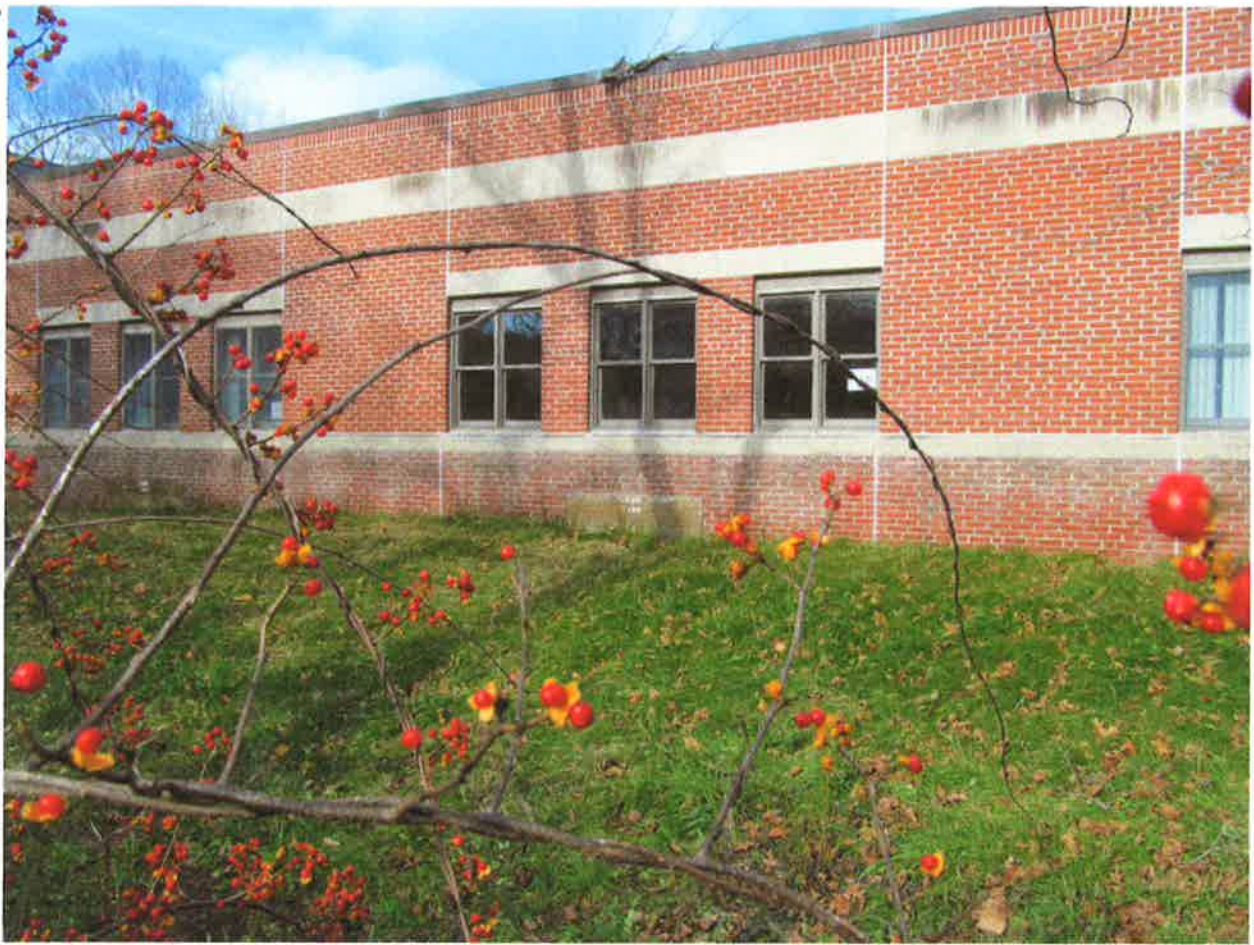
- A field review of the area around the above CB revealed plywood flood covers on the unit ventilators to rooms 105, 106 & 107 and the presence of lead shields for bolting covers onto other ventilators in this same area.

Flood boards at room 106 & 107

- Provide stormwater detention for any new impervious areas on-site.
- Eliminate the unit ventilators in each classroom and in-fill the openings to eliminate the potential for water infiltration, thus reducing the number of possible flood water entry points.
- Provide an easily deployable system to flood proof the culvert door in the basement, the main entry doors/windows and three (3) sets of entry doors.

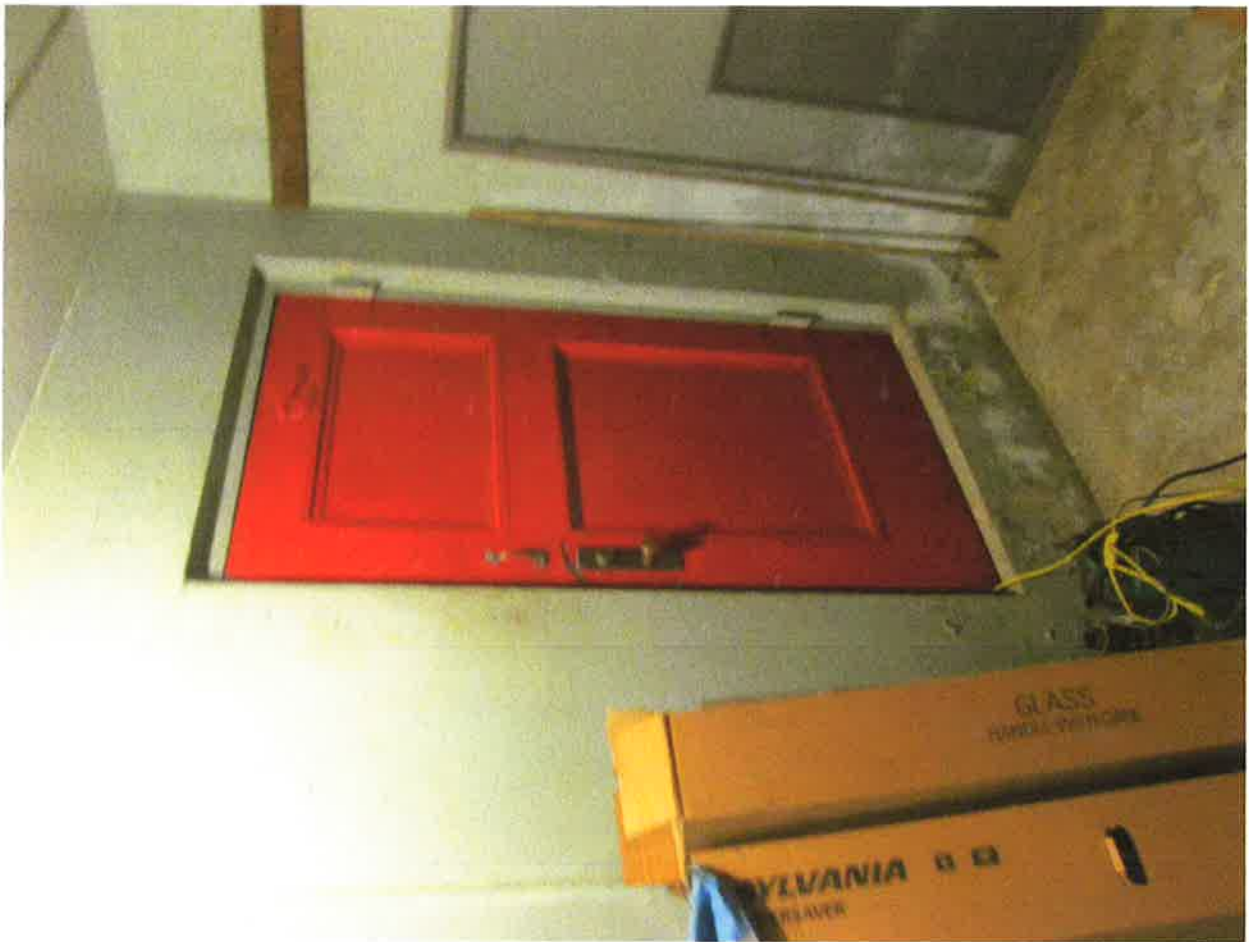
outer door to culvert

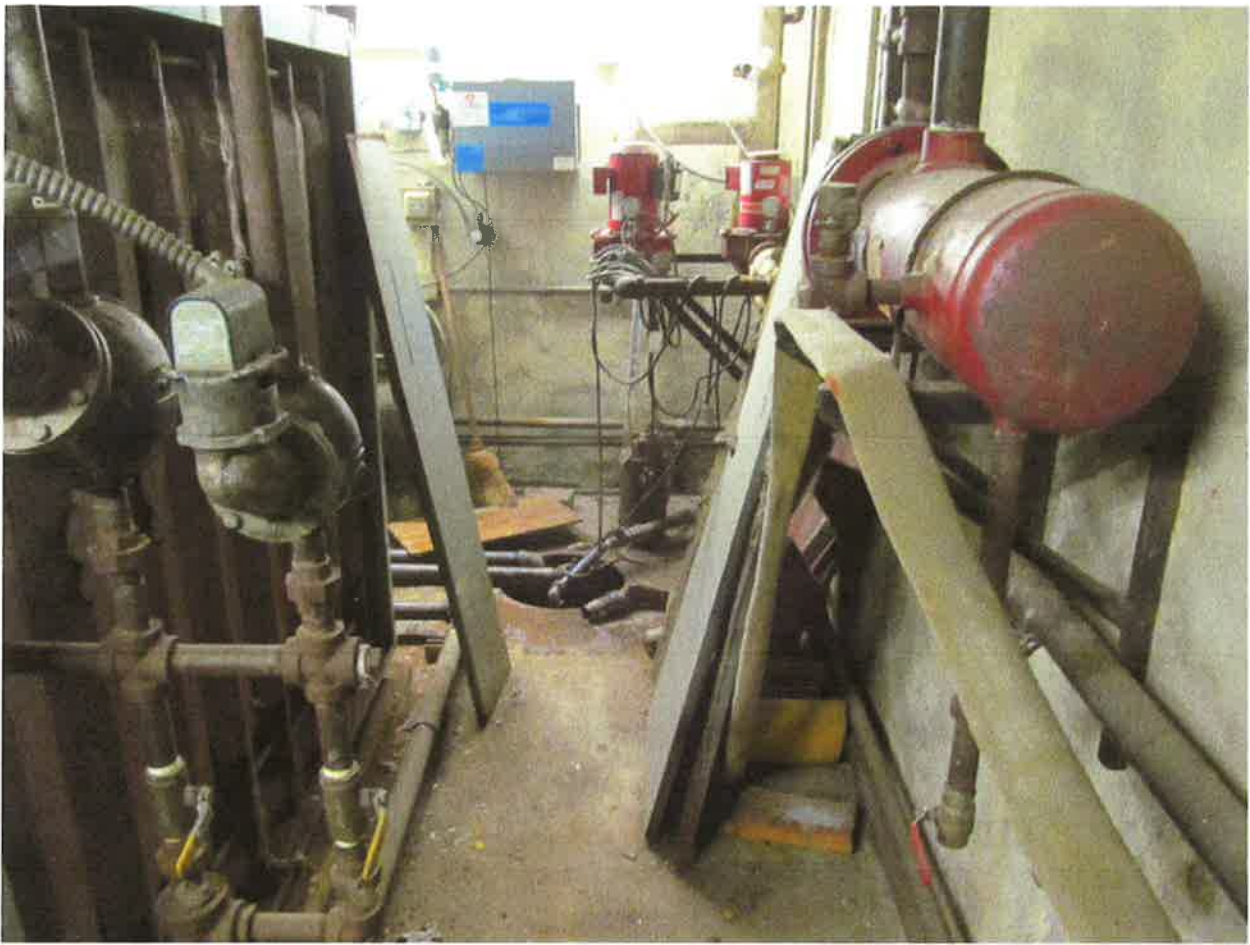
Boiler room sump pump - small pump for normal operations

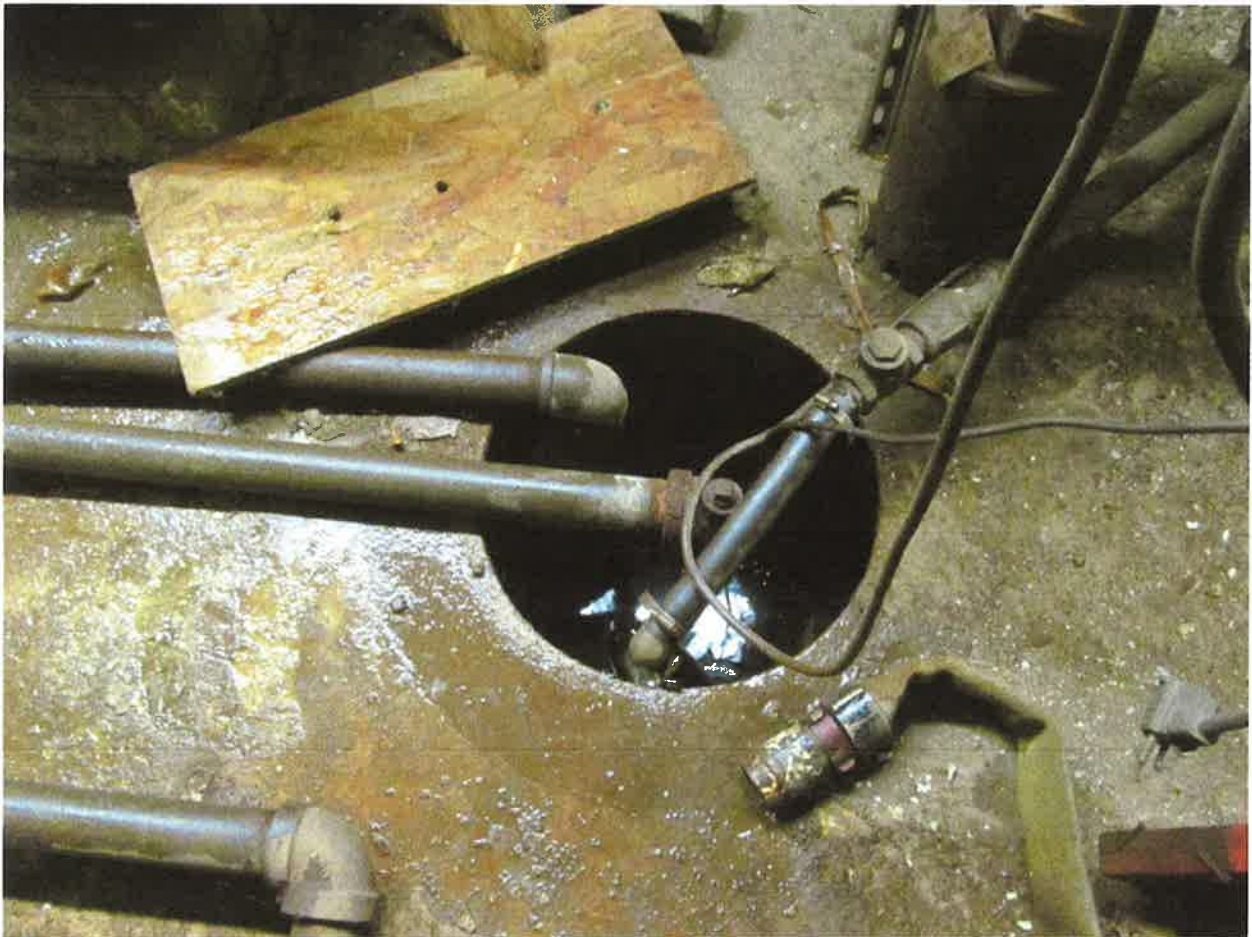
install bigger pump and connect to firehose when needed
Hinsdale School - 11/14/18
