FACILITY ASSESSMENT AND RENOVATION

Mary P. Hinsdale School
15 Hinsdale Avenue
Winchester, Connecticut

April 6, 2019

Presented by: Silver Petrucelli & Associates, Inc.

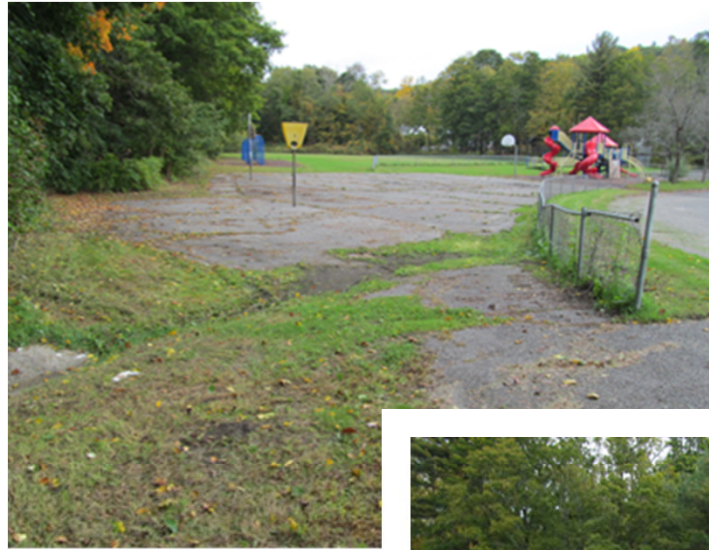
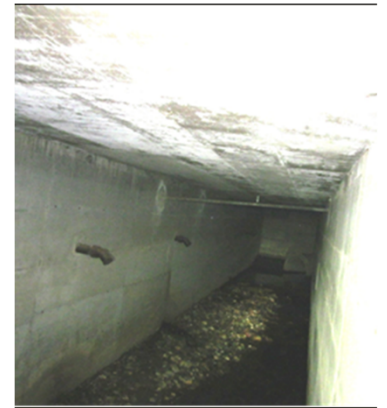
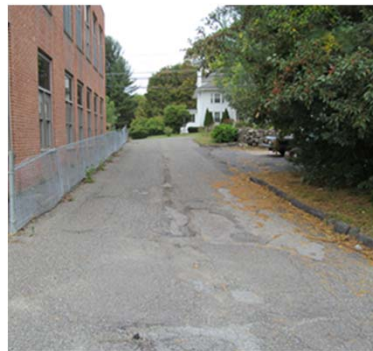
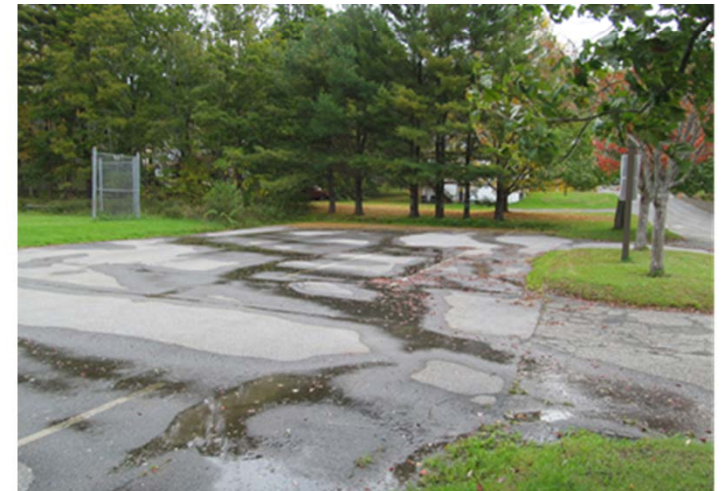
- Drainage
- Flooding
- Paving & Curbing
- Utilities
- Accessibility
- Circulation
- Recreation & Play Areas

Hinsdale School			
FACILITY EXISTING CONDITIONS ANALYSIS			
TAG NO.	ASSESSMENT	SYSTEM/ CODE REFERENCE	CORRECTIVE ACTION
SITE CONDITIONS			
S1	Watercourse runs under the school and can flood the site and building in a severe storm event.	Civil	Remove two story original portion of building to restore open watercourse and eliminate site and building flooding. Minor relocation of the domestic water and fire sprinkler services are required in conjunction with the abandonment of the existing subterranean boiler
S2	Lack of existing parking and loss of parking with proposed building addition.	ADA	Construct new, on-site parking area to off-set parking spaces lost by building addition. The work also includes construction of a small stormwater management area to mitigate increase in stormwater runoff
S3	New 5-12 year old play structure and surface, and new PK-K play structure and surface		New play structure is required due to removal of existing play structure in order to construct on-site parking. New PK-K playground required in the Ed. Spec.

S4	Paving, curbing and plaza are in poor condition and do not meet accessibility requirements.	ADA	Replace sidewalks, paving and curbs and redo pedestrian transitions as needed.
S5	Parking lot and overall site drainage is poor. Sheet flow and icy conditions are common.		Some minor drainage relocations, new drainage structures and drainage connections are required by renovations and the proposed building expansion.
S6	Existing bollards, signs, fencing and misc. items are in poor condition		Site improvements recommended for misc. items noted.

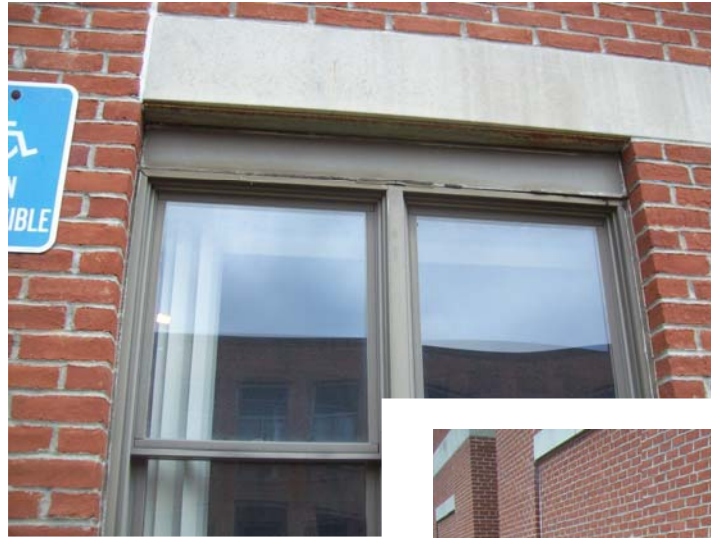
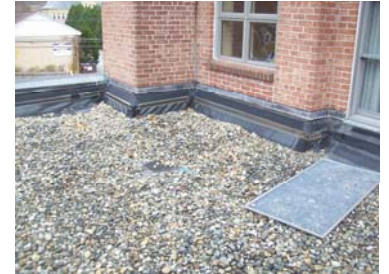
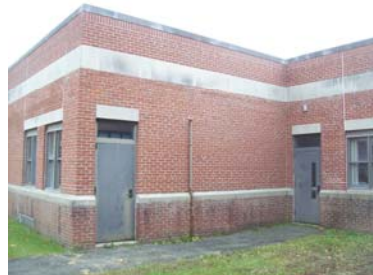
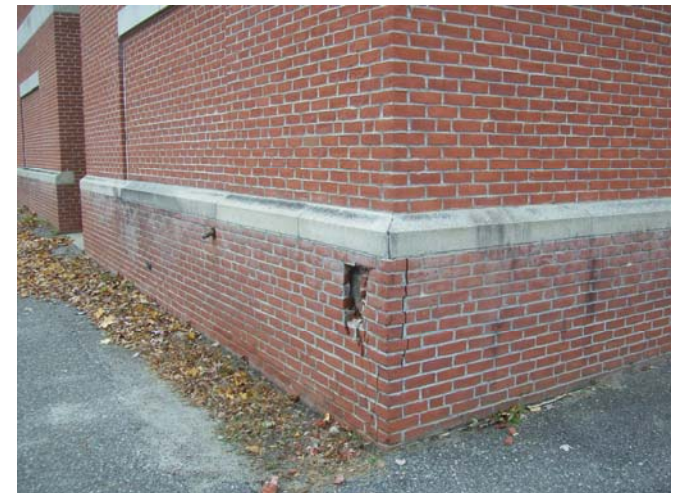
Roof Replacement

Window Condition

Door Accessibility

Masonry Repairs

Hinsdale School			
FACILITY EXISTING CONDITIONS ANALYSIS			
TAG NO.	ASSESSMENT	SYSTEM/ CODE REFERENCE	CORRECTIVE ACTION
ARCHITECTURAL - EXTERIOR CONDITIONS			
A1	Minor brick repair/replacement and some mortar is in need of repointing. Significant mildew and staining on brick/masonry surfaces. Deteriorated sealant joints.	General	Patch, repair, or replace brick and repoint. Power wash as necessary. Minor concrete repair as needed. Prime and paint steel lintels as applicable. Clean mildew and staining on brick/masonry surfaces. Replacement of all sealant joints.
A2	Door thresholds or concrete pads have a greater than 1/2" transition to grade. Steps at many doors.	ANSI 117 (ADA)	Provide ramp or re-pave to allow for 1/2" maximum vertical transition.
A3	Windows and glazing date from 1988 addition and are in fair to poor condition, with some broken windows.		Window and glazing system lifespan is generally considered 30-40 years. Window replacement recommended with safety glass and new screens. Energy savings benefit.

A4	Roofs are nearing the end of their useful life		Full roof replacement is recommended.
A5	Exterior soffit cracks and poor overall condition		Repair and replace sections as needed.
A6	Exterior doors rusting and sticking		Exterior door replacement recommended
A7	HVAC louver vents abandoned, not required		Infill of low, former HVAC louver vents to match adjacent brick

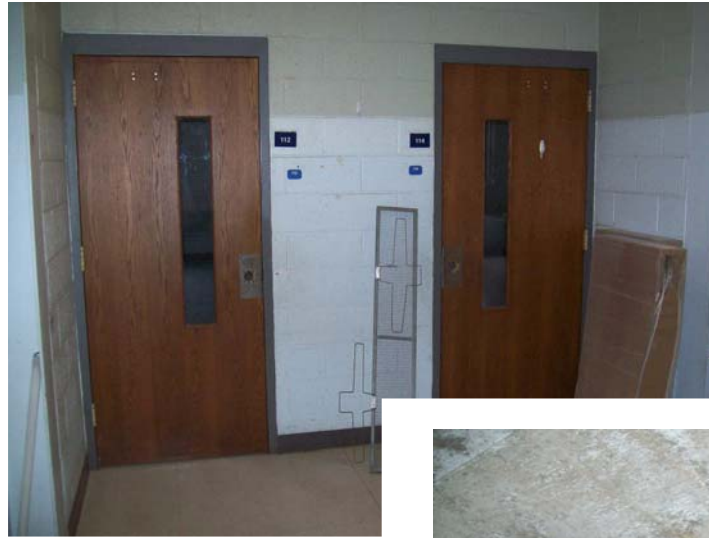
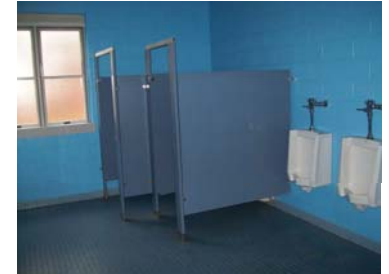
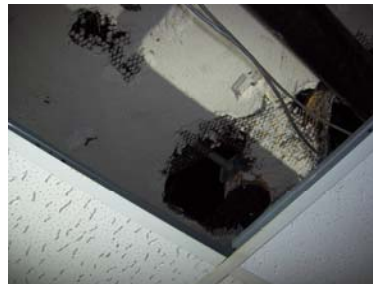
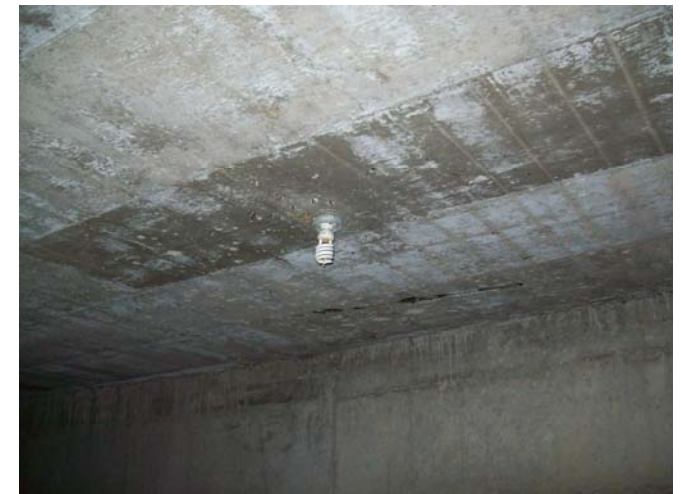
Door Clearances & Hardware

Bathroom ADA Accessibility

Current Moisture Issues

Hinsdale School			
FACILITY EXISTING CONDITIONS ANALYSIS			
TAG NO.	ASSESSMENT	SYSTEM/ CODE REFERENCE	CORRECTIVE ACTION
ARCHITECTURAL - INTERIOR CONDITIONS			
A8	Many door push and/or pull maneuvering clearances do not meet code. Includes conditions where the jamb thickness is larger than 8" beyond face of door.	413.6 (ADA) 1101.2 (IBC) ANSI 117.1	Where obstruction is not furniture related, modify door swing and/or location to comply. Where the previous is not easily achieved, supply push button door operator where required.
A9	The required toilet grab bars are not installed. Sinks do not meet accessibility requirements.	(B)1108.0 (ANSI A117.1) 603-606	Install code required grab bars. Replace toilet and sink fixtures.
A10	Cabinetry is in poor condition. Required accessible work spaces and sinks do not exist in original cabinetry. Full cabinet replacement recommended.		Full cabinet replacement recommended.

A11	Some door hardware is not accessible. Knob handles require grasping and twisting.	4.13.9 (ADA) 404.2.6 (ANSI 117.1)	Remove door locksets and install new accessible lever handle locksets where designated.
A12	Handicap signage at doors is missing and does not comply with current code.		Provide new signage around building.
A13	Existing kitchen prep area does not meet accessibility requirements and clearances		New kitchen provided in design
A14	Finish flooring in fair to poor condition		Replace flooring to refresh spaces
A15	Sagging ceilings		Replace ceilings to refresh spaces
A16	Interior painted surfaces old and dull		Repaint rooms to refresh spaces

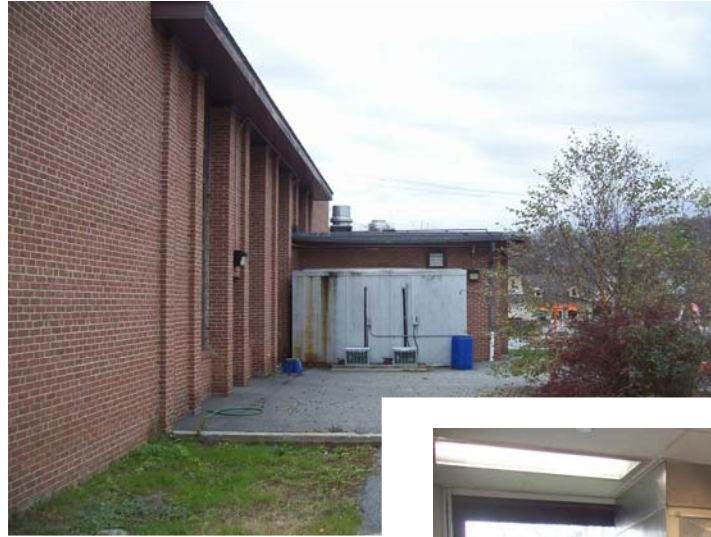
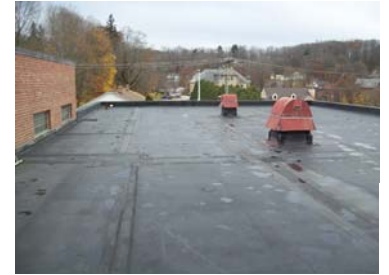
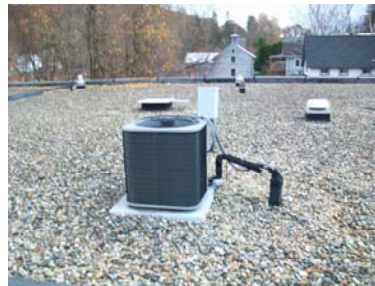
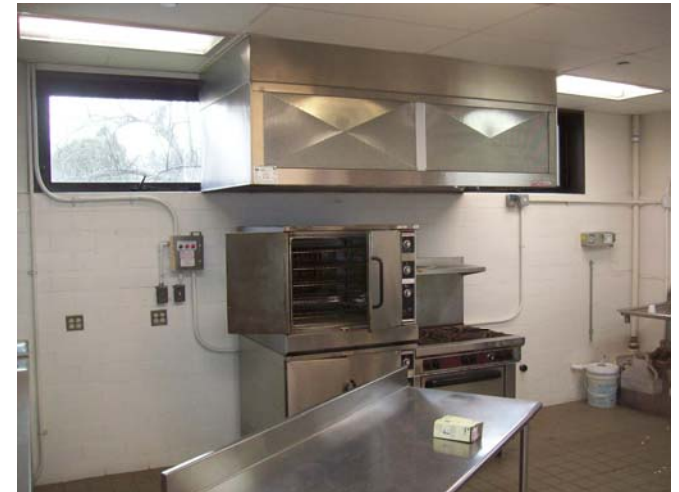
New HVAC System

New Kitchen Exhaust Fan

Hinsdale School			
FACILITY EXISTING CONDITIONS ANALYSIS			
TAG NO.	ASSESSMENT	SYSTEM/ CODE REFERENCE	CORRECTIVE ACTION
MECHANICAL SYSTEMS			
M1	Existing kitchen hood, ventilation system has outlived its useful life expectancy and might not meet the latest code requirements.		If the building is repurposed and the intent is to keep the kitchen operational we strongly recommend replacing the entire ventilation system. Provide new exhaust hood, makeup air unit and UL762 compliant fan.
M2	The existing boilers are over 30 years and are past their useful life. The lower boiler room is below grade and adjacent to the underground stream. The stream has flooded and subsequently has flooded the adjacent boiler room.		Recommend that the boilers be removed and the lower boiler room be re-purposed as another room.
M3	Baseboard fin tube radiation should be removed.		The new system will consist of gas fired RTU's with energy wheels and fan powered VAV boxes that are more efficient and more effective. The new system will provide Heating, Ventilation and Air Conditioning.

M4	Building exhaust fans have outlived their useful life expectancy.		Replace with replacement fans that are properly sized and code compliant during renovations.
M5	Building management system has outlived its useful life expectancy and it is dated.		Replace system if a major project is undertaken to replace the building's HVAC systems with a modern and expandable system to monitor and control the school.

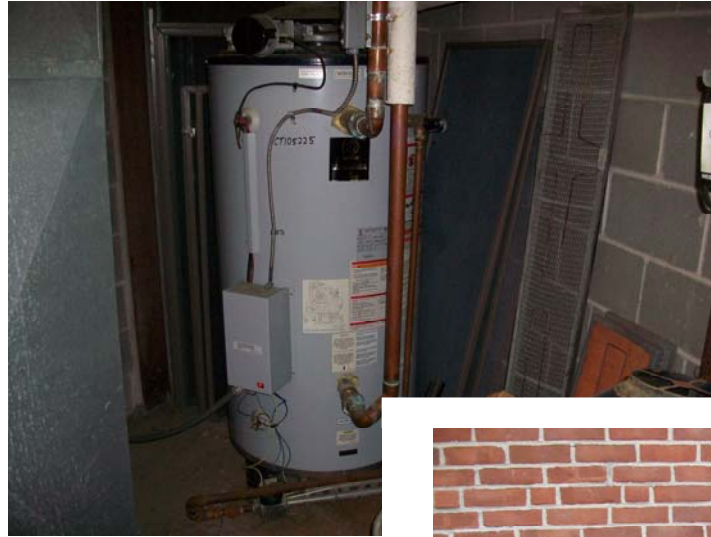
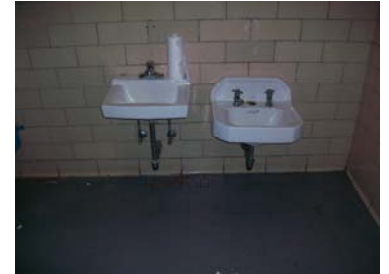
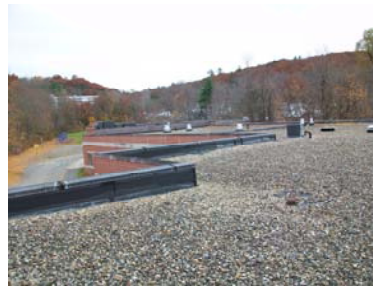
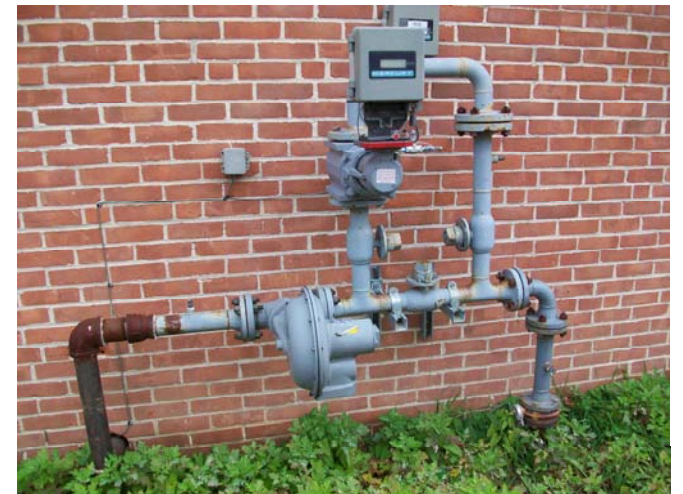
Relocate Domestic Water Service

New Water Heaters

Bathroom Fixtures

Roof Drainage

Hinsdale School			
FACILITY EXISTING CONDITIONS ANALYSIS			
TAG NO.	ASSESSMENT	SYSTEM/ CODE REFERENCE	CORRECTIVE ACTION
PLUMBING			
P1	Boiler room, Below flood plain	2015 IBC / 2015 IPC	Relocate all equipment, water heaters, water meters, pumps, etc. above the anticipated flood level elevation
P2	Water heater #1's thermostatic mixing valve not compliant	2015 IPC	System will require a new NSF 61 compliant 1017 Thermostatic Mixing Valve (TMV)
P3	Water heater #2 Pump and Thermostatic Mixing Valve not compliant	2015 IPC	Recirculation pump is in poor operating condition and was observed leaking, replacement is recommended immediately. Currently the system is not provided with a thermostatic mixing valve, Provide a new NSF 61 compliant 1017 TMV
P4	Plumbing Fixtures, Urinals not compliant	2015 IPC	Existing floor mounted urinals shall be replaced with wall hung type with partitions.
P5	Plumbing Fixtures, General	2015 IPC	Some bathrooms are provided with non-ADA compliant wash stations, these should be replaced. All lavatories shall be provided with ADA compliant insulation on drain and supply lines and shall have 1070 thermostatic mixing valves.

P6	Roof drainage, Overflow provisions not observed in all locations	2015 IPC	Means of secondary roof drainage should be provided per code to ensure the roof's structural integrity is intact in the event of excessive ponding or water accumulation caused by primary drain obstructions

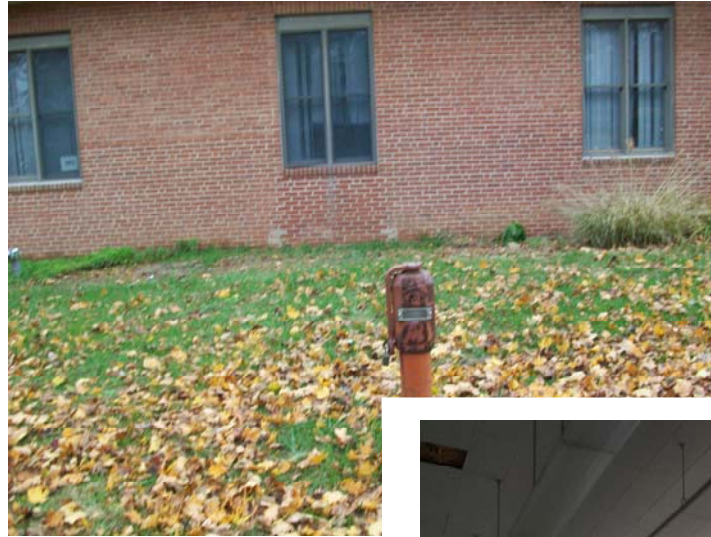
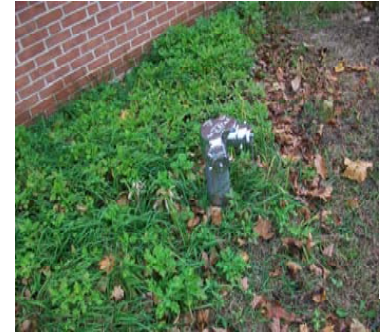
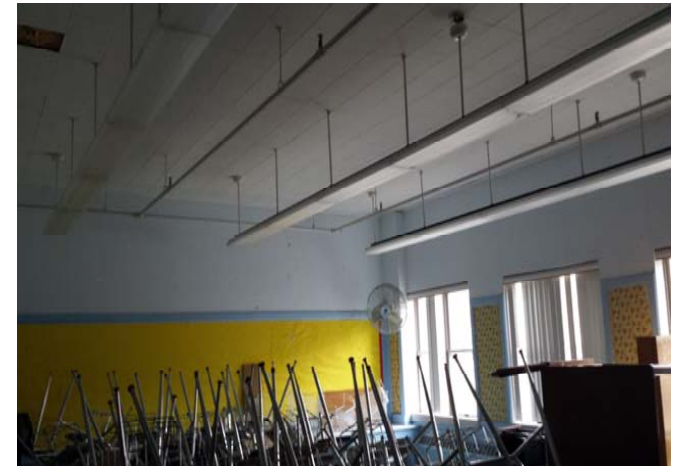
Sprinkler System:

Attic / Above Ceiling Areas

Hinsdale School			
FACILITY EXISTING CONDITIONS ANALYSIS			
TAG NO.	ASSESSMENT	SYSTEM/ CODE REFERENCE	CORRECTIVE ACTION
FIRE PROTECTION			
FP1	Building is not currently fully protected with a sprinkler system (no protection in combustible attics)	NFPA 13	Provide sprinkler system for combustible attics to achieve fully sprinklered building per NFPA 13
FP2	Modify basement service entrance to be above floodplain	General	Reroute fire service and provide new backflow preventer and wet/dry system risers in new 1st Floor Sprinkler Room
FP3	Reconfiguring of existing spaces	General	Modify sprinkler layout as needed in renovated, reconfigured rooms and provide full sprinkler coverage in addition.

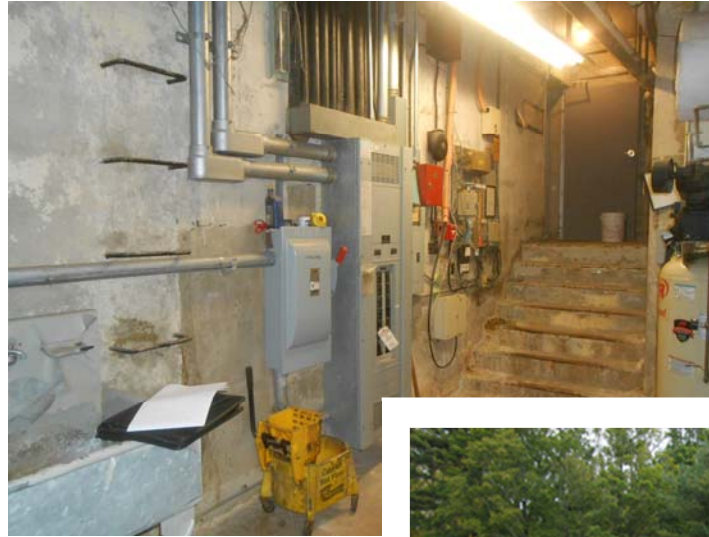
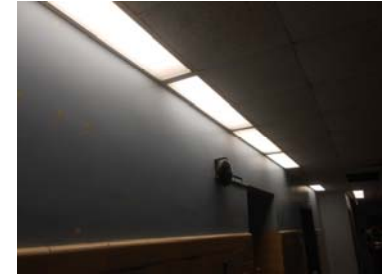
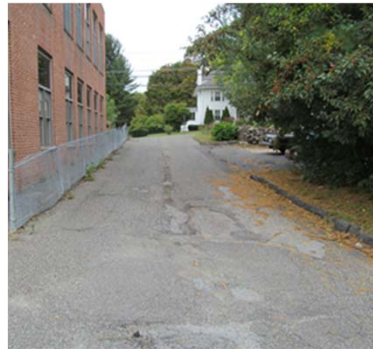
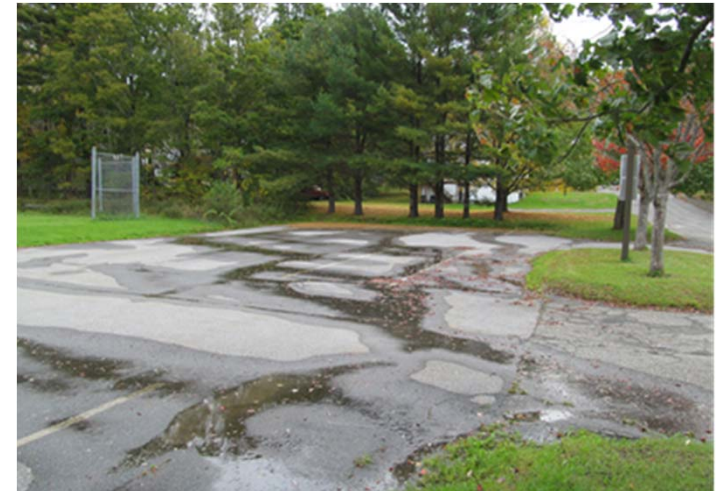
New Electrical Service

Interior Emergency Lighting

New PA System

Hinsdale School			
FACILITY EXISTING CONDITIONS ANALYSIS			
TAG NO.	ASSESSMENT	SYSTEM/ CODE REFERENCE	CORRECTIVE ACTION
ELECTRICAL SYSTEMS			
E1	The existing Fire Alarm System does not meet the current code requirements.		Testing & certification is required before opening the building. Additional devices will be needed in areas lacking coverage and in the new addition.
E2	Currently the emergency lighting is provided by single point products.		Most lights were outdated and a large amount were broken and inoperable. All units will be replaced with new.
E3	Existing fluorescent lighting will not meet current codes (30% reduction (by level lighting = 50% plug load control.		Existing building light fixtures are being replaced by Eversource Energy with new energy efficient LED fixtures. New LED fixtures will be provided in the new addition. Add control panels to convenient power receptacles in all classrooms

E4	Exterior Building lighting - will not meet current codes		All exterior building lighting will be removed and replaced with exterior LED products.
E5	Exterior emergency lighting - path of egress illumination		All exterior emergency lighting will be removed and replaced with LED emergency lights to meet current code.
E6	Emergency generator		The building currently has no generator. A new 200KW natural gas powered, 208/120V, 3ph, 4w generator and 800A transfer switch will be provided.
E7	Main electrical service will need to be moved to the Main Level from the Basement.		All new electrical service equipment and panels will be provided.
