FACILITY ASSESSMENT AND RENOVATION

Mary P. Hinsdale School
15 Hinsdale Avenue
Winchester, Connecticut

April 6, 2019

Presented by: Silver Petrucelli & Associates, Inc.

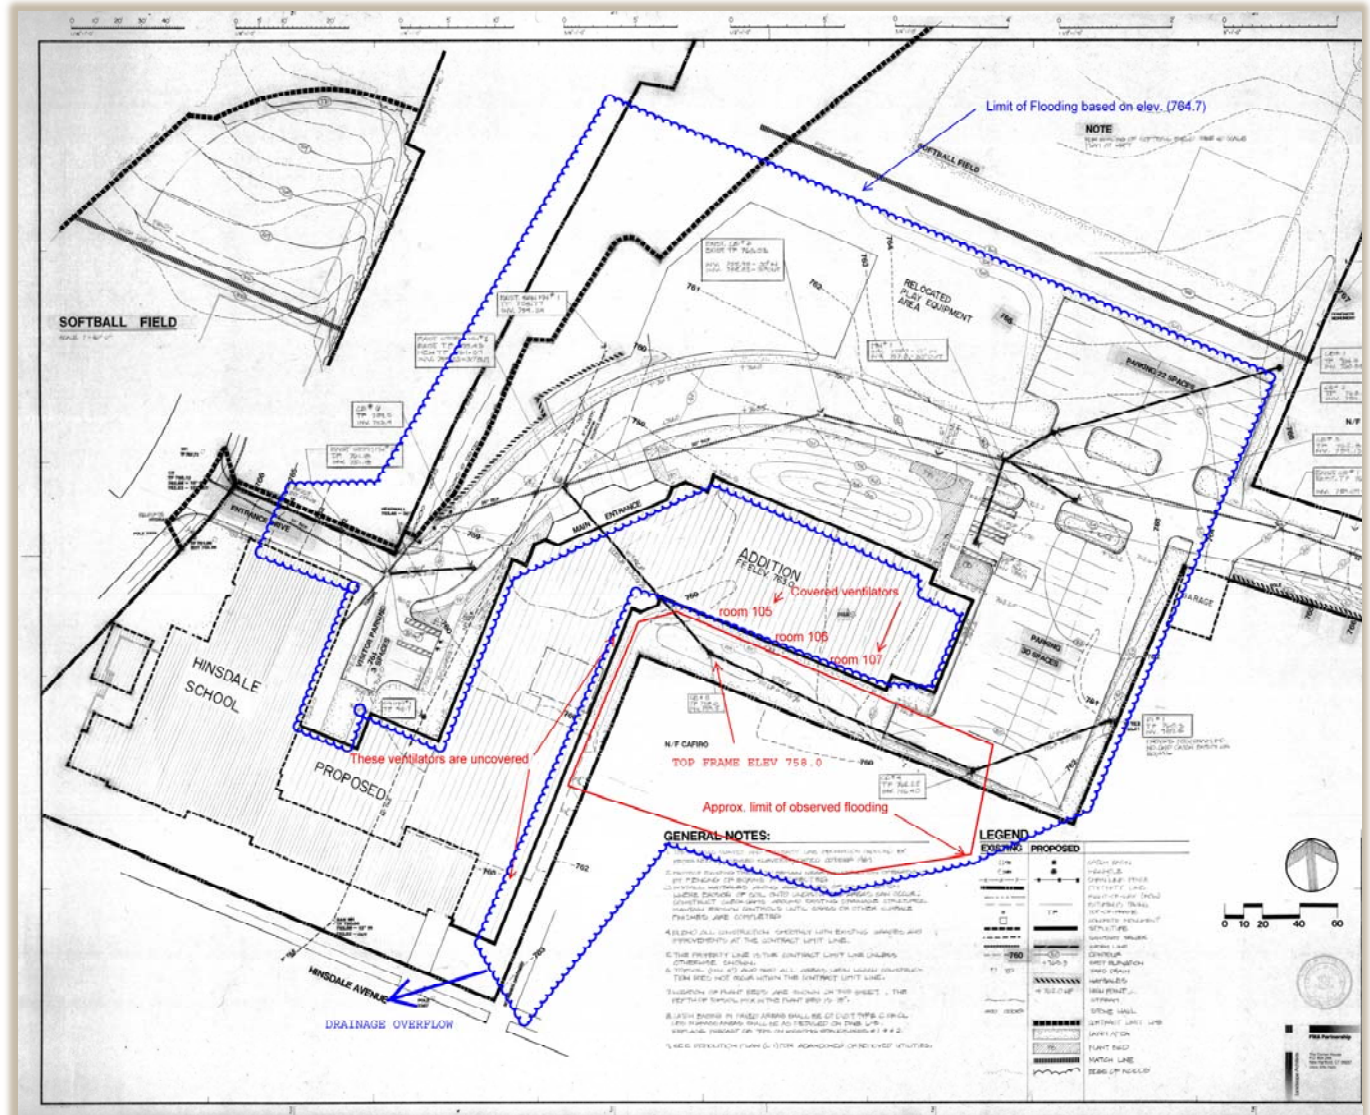
Flood Plain

Hinsdale School			
FACILITY EXISTING CONDITIONS ANALYSIS			
TAG NO.	ASSESSMENT	SYSTEM/ CODE REFERENCE	CORRECTIVE ACTION
PLUMBING			
P1	Boiler room, Below flood plain	2015 IBC / 2015 IPC	Relocate all equipment, water heaters, water meters, pumps, etc. above the anticipated flood level elevation
P2	Water heater #1's thermostatic mixing valve not compliant	2015 IPC	System will require a new NSF 61 compliant 1017 Thermostatic Mixing Valve (TMV)
P3	Water heater #2 Pump and Thermostatic Mixing Valve not compliant	2015 IPC	Recirculation pump is in poor operating condition and was observed leaking, replacement is recommended immediately. Currently the system is not provided with a thermostatic mixing valve, Provide a new NSF 61 compliant 1017 TMV
P4	Plumbing Fixtures, Urinals not compliant	2015 IPC	Existing floor mounted urinals shall be replaced with wall hung type with partitions.
P5	Plumbing Fixtures, General	2015 IPC	Some bathrooms are provided with non-ADA compliant wash stations, these should be replaced. All lavatories shall be provided with ADA compliant insulation on drain and supply lines and shall have 1070 thermostatic mixing valves.
